ENGINEERING EXPERIMENT STATION
BULLETIN 487

**MEDIANS OF DIVIDED
HIGHWAYS — FREQUENCY
AND NATURE OF VEHICLE
ENCROACHMENTS**

Project IHR-59

Widths and Cross Sections for

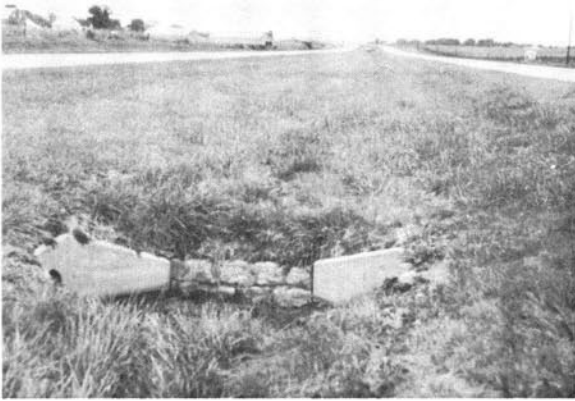
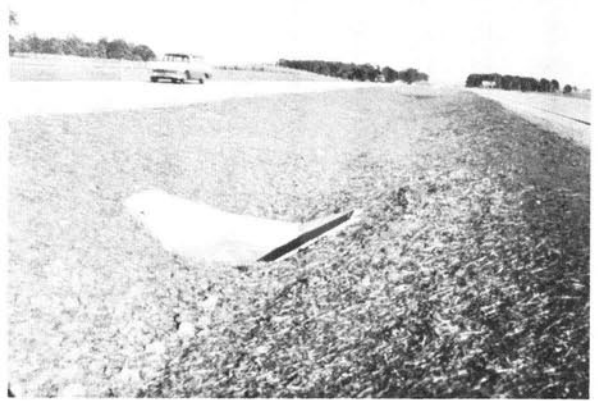
FIGURE D1. MEDIAN OBSTACLES AND ENCROACHMENTS

18-inch depression of median ditch invert at culvert openings on U.S. Route 66 south of McLean and on recently constructed F.A.I. Route 74 east of Urbana (earth berm in median in background of both photographs).

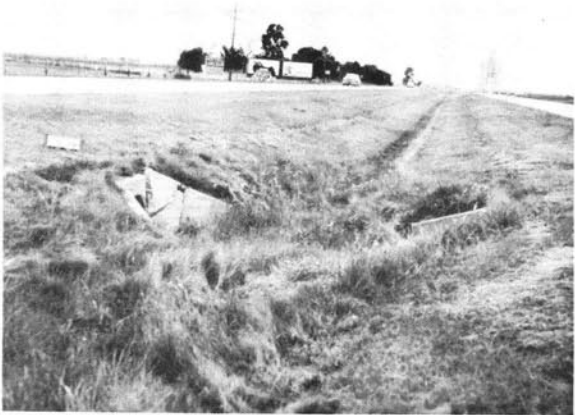
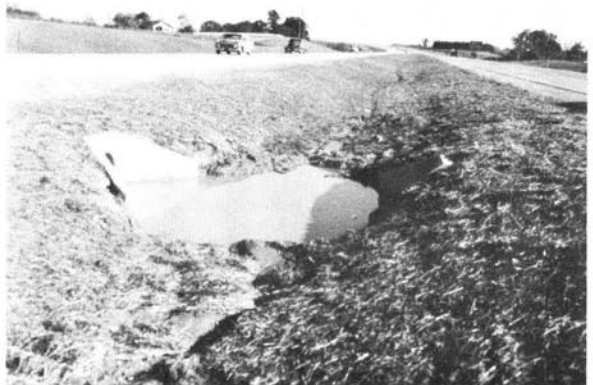
FIGURE D2. MEDIAN OBSTACLES AND ENCROACHMENTS

Headwalls on culverts open to the median on U.S. Route 66 north of Lawndale and on F.A.I. Route 74 east of Urbana (headwall at left shows damage from truck collision).

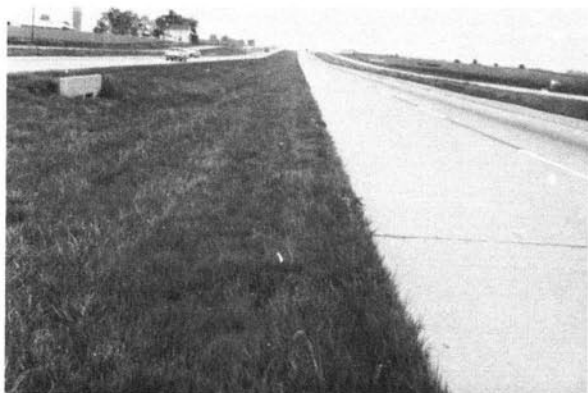
FIGURE D3. MEDIAN OBSTACLES
AND ENCROACHMENTS

*Culvert headwall in median of U.S.
Route 66 north of U.S.
Route 52 interchange.*

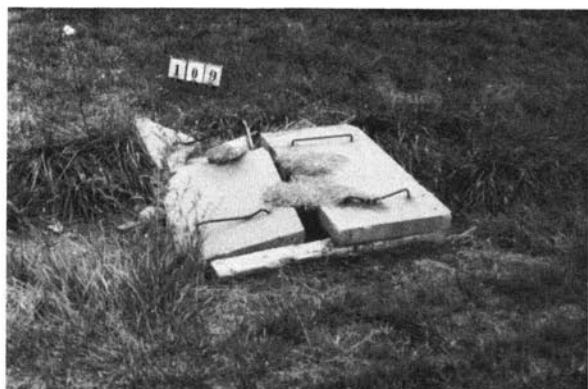
FIGURE D5. MEDIAN OBSTACLES
AND ENCROACHMENTS

*Drainage inlet with concrete cover one
foot higher than median ditch invert
on U.S. Route 66 south of Chenoa.*

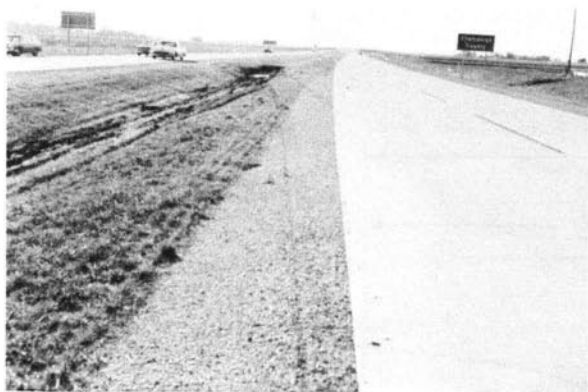
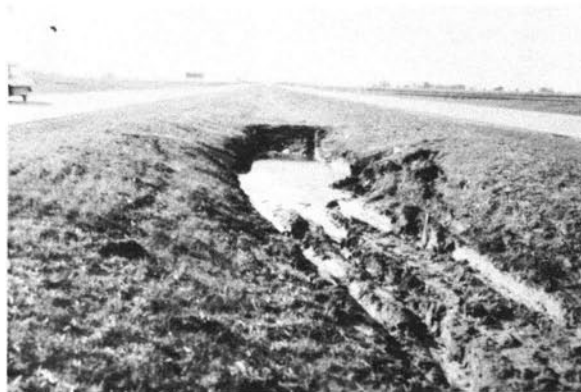
FIGURE D6. MEDIAN OBSTACLES AND ENCROACHMENTS

*General view (left) and close-up (right) of tracks made by
encroaching vehicle that passed between two culvert headwalls
and collided with earth berm in F.A.I. Route 74 median.*

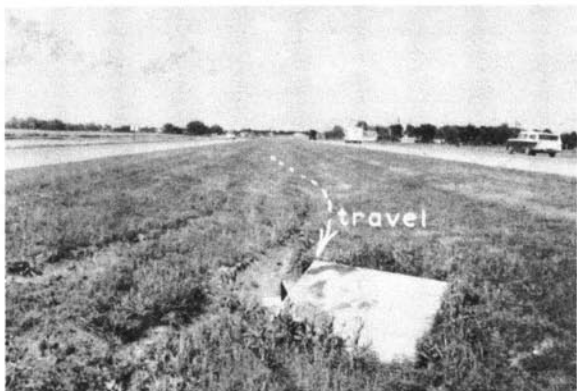
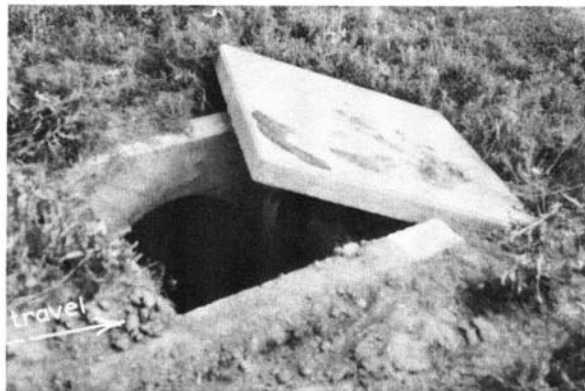
FIGURE D7. MEDIAN OBSTACLES AND ENCROACHMENTS

General view (left) and close-up (right) of results of collision of encroaching vehicle with 800 pound concrete drainage inlet cover in U.S. Route 66 median east of Rolla, Missouri.

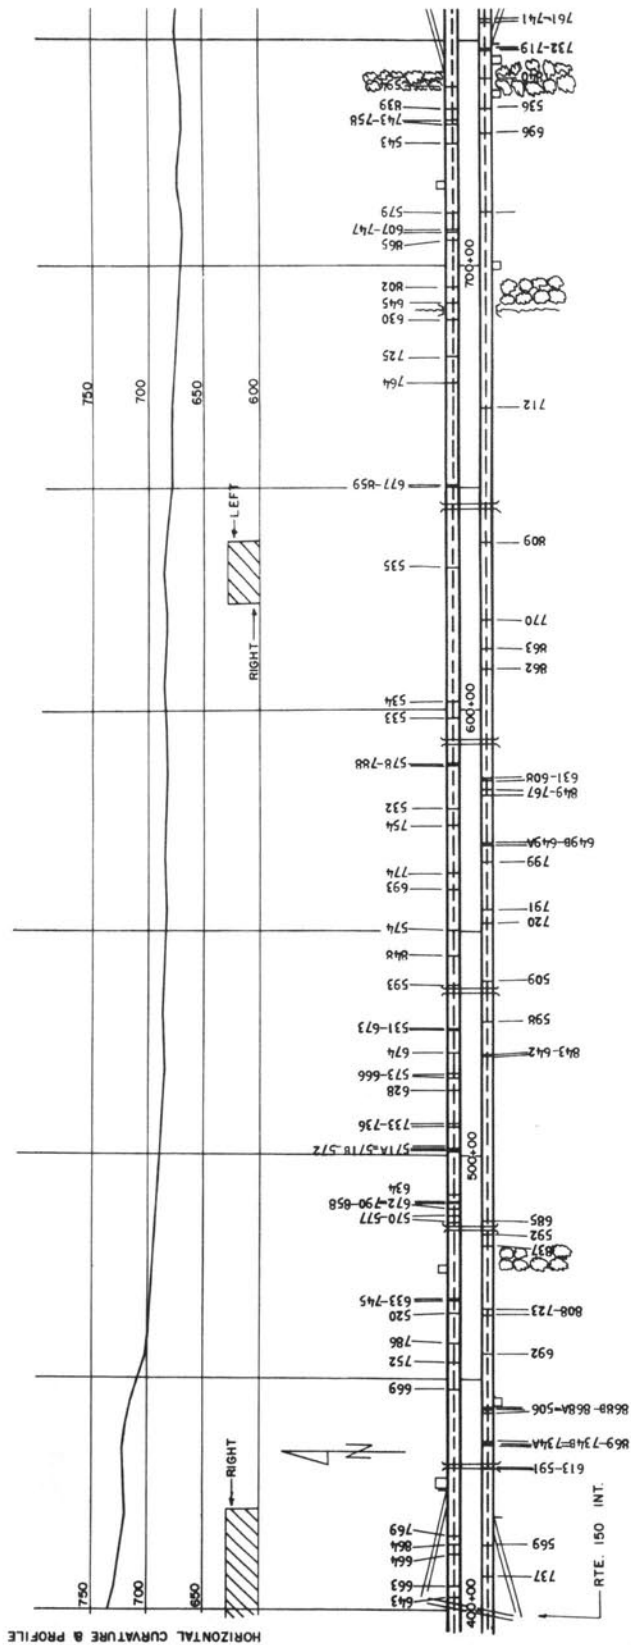
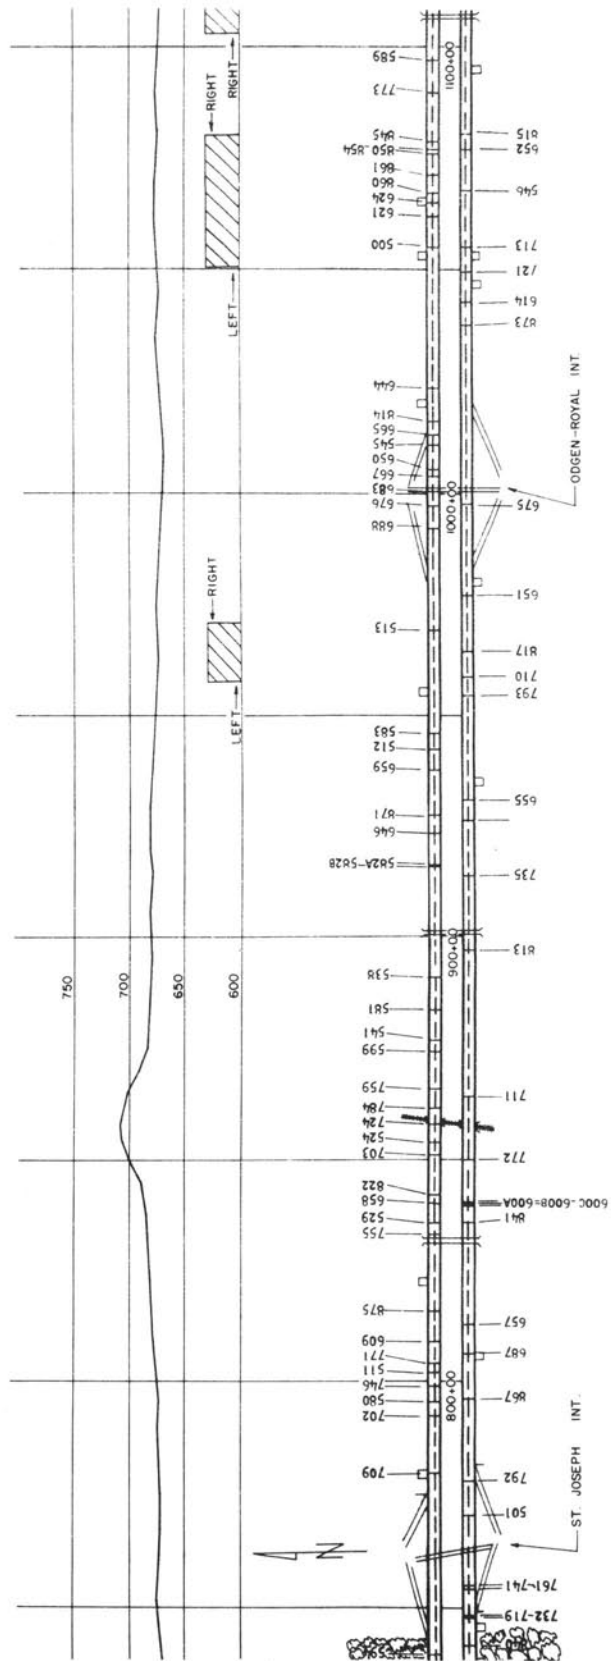
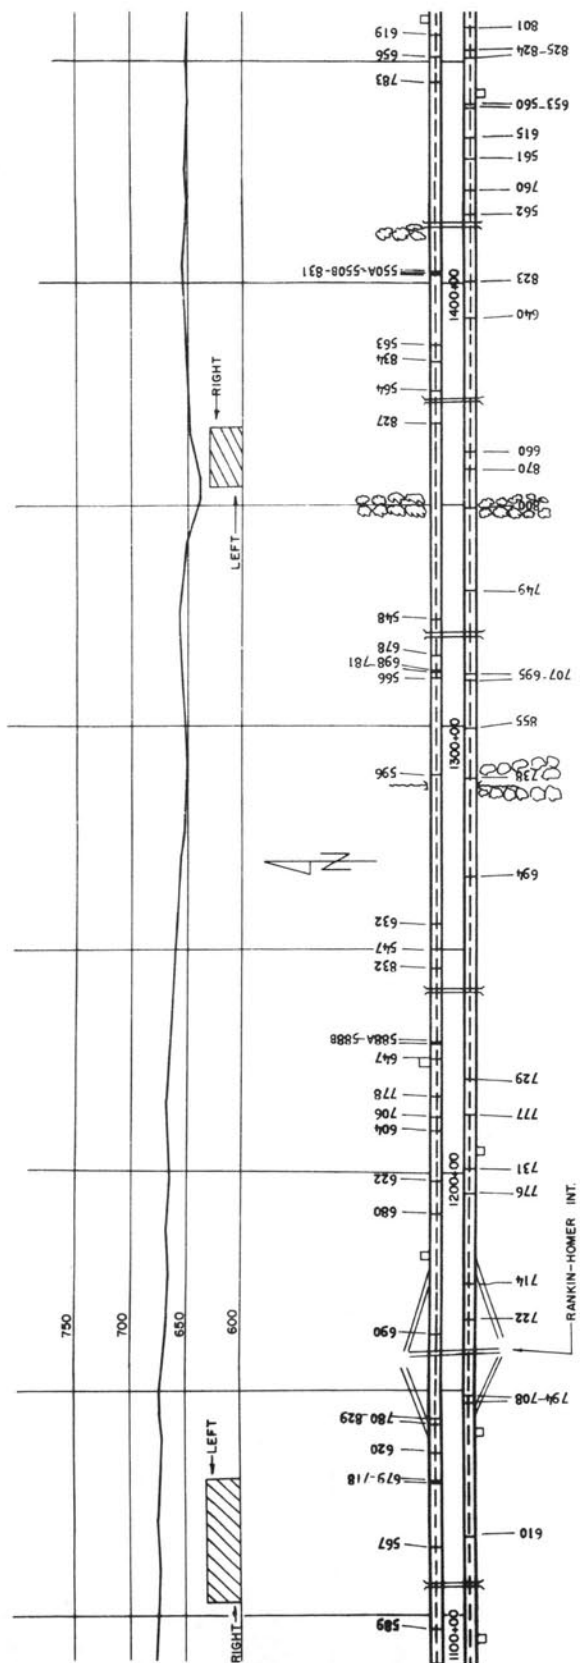
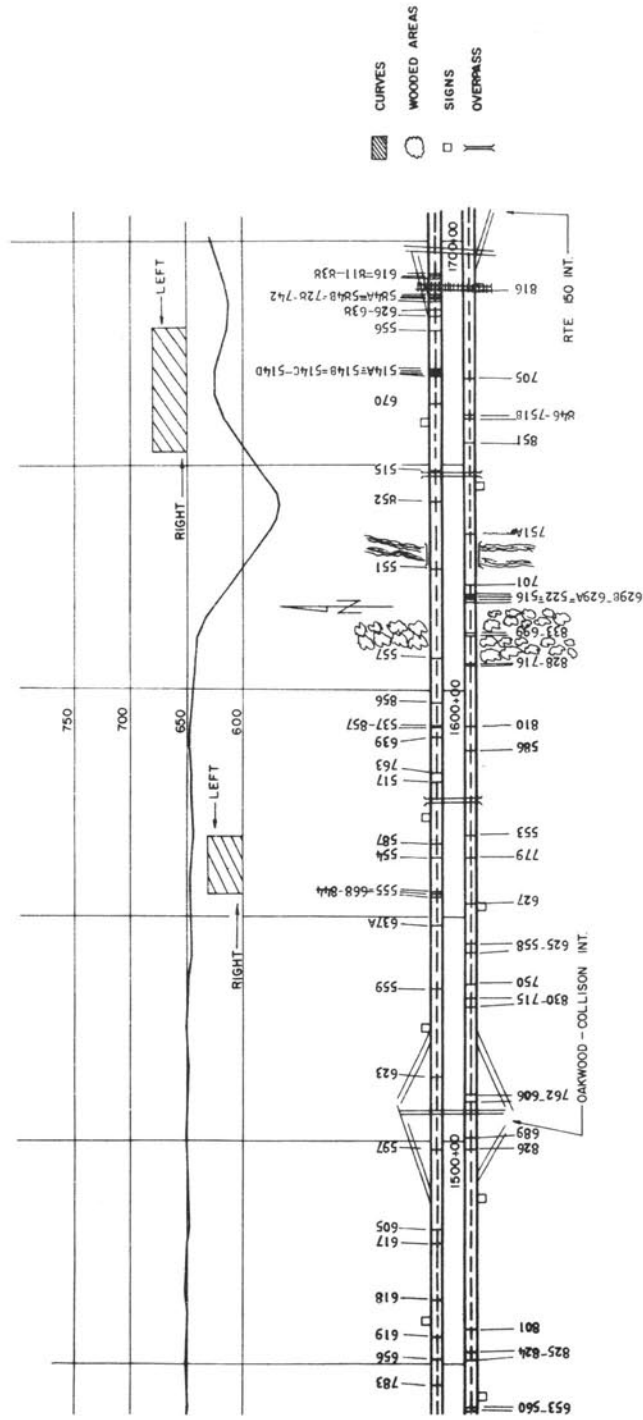
MAP 4. STRIP MAP OF F.A.I. ROUTE 74

A strip map of the 24.6-mile study section (see Map 4) illustrates roadway features, pavement station numbers, and the exact location of each of the 302 observed encroachments. The identification number for each encroachment is located next to the roadway from which the encroachment originated.
